**Flood Control Project Maintenance
Levee Inspections**

Fall 2016 Levee Maintenance Deficiency Summary Report

Reclamation District No. 0536 Egbert

Levee Inspection Report By Mile - Fall 2016

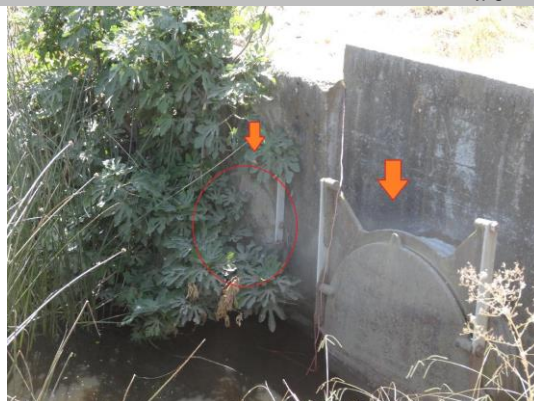
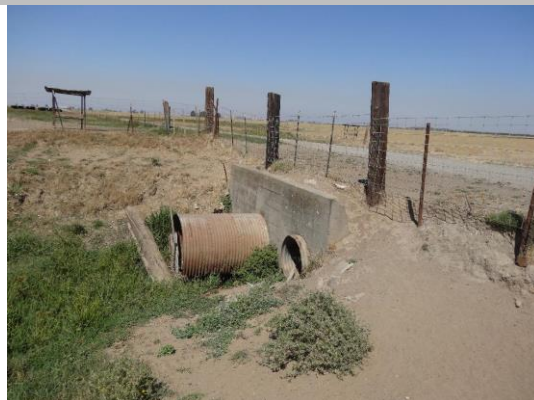
FS_ID:50161
DS_ID:22712
EP_NO: 10114
Repair Type: Urgent
Crossing Status: Found
UCIP Comments: 06/01/2016: Holes and heavy corrosion inside pipe on WS have gotten worse. Flapgates appear in good condition though vegetation blocks view of flapgate for 36-inch on WS. These pipes are still in use and necessary for drainage; pipes may be eligible for repair under DWR Deferred Maintenance Program. (K. Fazel - UCIP)08/13/2013:- Holes in pipe outlet due to heavy corrosion.- Needs detailed investigation of the pipe.- Headwall cracked and tilted on WS. (P. Amatya - DWR)
FIELD_STRUCT_DESC: 1 of 2: 60-inch corrugated metal drainage pipe through the levee, 10 feet below the crown. Flap gate on the waterside (WS) and headwall on the WS and landside (LS). Culverts run under the road to provide drainage from agricultural fields to Lindsey Slough. RD0536 president is David Hearn at hearnd5@gmail.com. (Automatic Board Order (ABO) issued as Permit No. 10114, 1974 - Patterson)

WS view: two CMPs with flap gates. Concrete headwall supports the pipes. A 36" CMP (left) and 60" CMP (right).

LS view: two inlet CMPs with flap gates. Concrete headwall supports the pipes. A 36" CMP (right) and 60" CMP (left).

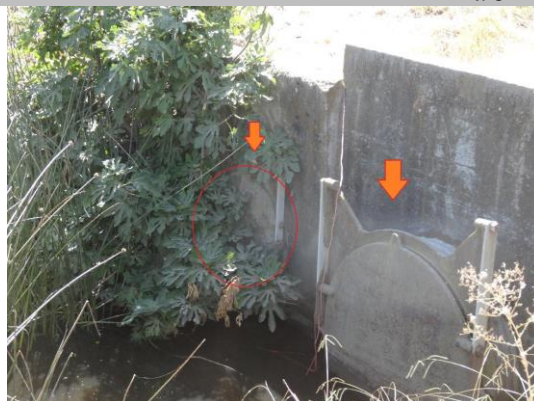
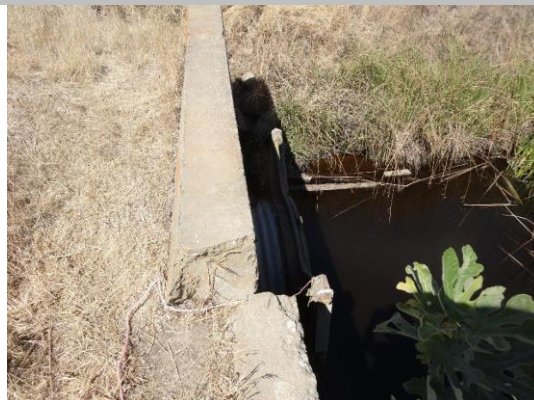
FS_ID:50160
DS_ID:22726
EP_NO: 10114
Repair Type: Urgent
Crossing Status: Found
UCIP Comments: 06/01/2016 Pipe is not abandoned. Though neglected, it is still functional and a needed system feature. Pipe is severely corroded with holes in it, which are visible on LS. Vegetation blocks view of flapgate on WS. Pipes may be eligible for repair under DWR Deferred Maintenance Program. (K. Fazel - UCIP)08/13/2013 This pipe seems to be abandoned. Headwall cracked and tilted on WS. (P. Amatya)
FIELD_STRUCT_DESC: 2 of 2: 36-inch corrugated metal drainage pipe through levee, 10 feet below the crown. Flap gate on the waterside (WS) and headwall on the WS and landside (LS). Culverts run under the road to provide drainage from agricultural fields (via LS ditch) to Lindsey Slough. RD0536 president is David Hearn at hearnd5@gmail.com. (Automatic Board Order (ABO) issued as Permit No. 10114, 1974 - Patterson). [Additional Reference(s): DWR Levee Log, 1992. USACE Sacramento O&M manual 106, May 1953 (Station 294+49)].

WS view: concrete headwall, flap gates on 36" CMP (left) and 60" CMP (right)

WS view: cracked and tilted concrete headwall.

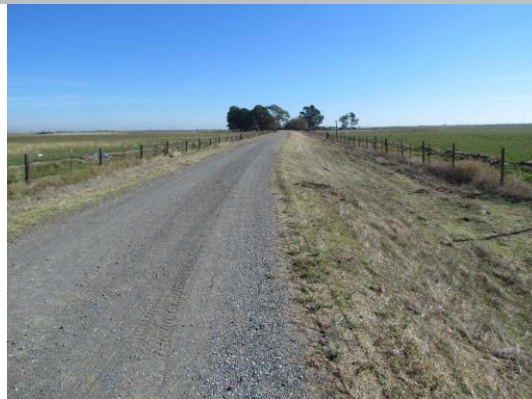
RD 536 Unit 1 levee mile 0.02 landside slope.

LM Start	0.02	Rating **	A	Issue No.	17
LM End	1.04	Issue Type +	Ma	Location *	LS
Category	Earthen Levee			GPS Latitude/Longitude	
				Start	End
Item	Vegetation			38.244960 °	38.254640 °
				-121.768553 °	-121.757670 °
DWR ID	DWR_RD0536_01_f_2016_17				
Comment Code					
V1 : Control annual grass and weeds on the levee slopes and easements.					
Inspector Comment					
No unwanted vegetation here at levee miles 0.02-1.04.

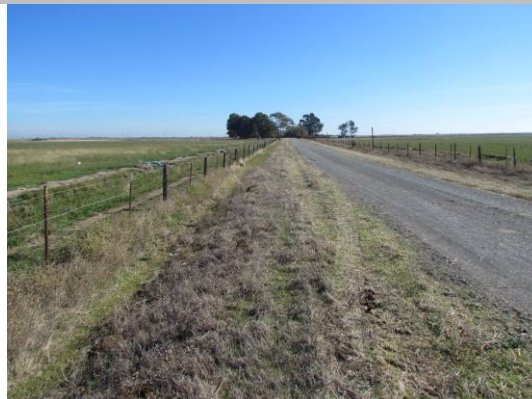
RD 536 Unit 1 levee mile 0.02 looking downstream.

LM Start	0.02	Rating **	A	Issue No.	18
LM End	1.57	Issue Type +	Ma	Location *	WS
Category	Earthen Levee			GPS Latitude/Longitude	
				Start	End
Item	Vegetation			38.244960 °	38.258705 °
				-121.768553 °	-121.753048 °
DWR ID	DWR_RD0536_01_f_2016_18				
Comment Code					
V1 : Control annual grass and weeds on the levee slopes and easements.					
Inspector Comment					
No unwanted vegetation between levee miles 0.02-1.57.

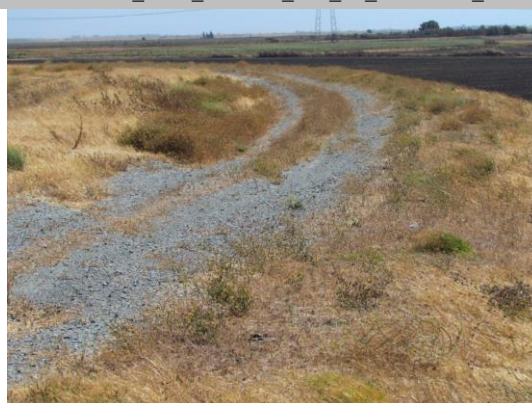
LM Start	2.69	Rating **	U	Issue No.	56
LM End	2.71	Issue Type +	Ma	Location *	CR
Category	Earthen Levee			GPS Latitude/Longitude	
				Start	End
Item	Crown Surface / Depressions / Rutting			38.255197 °	38.254973 °
				-121.737932 °	-121.737577 °
DWR ID	DWR_RD0536_01_f_2014_56				
Comment Code					
C2 : Repair depressions or ruts in the crown or slope.					
Inspector Comment					
District need to monitor the levee crown roadway at this location. There are some issues here.

Looking downstream at crown roadway there is still some settling going on here at this location.

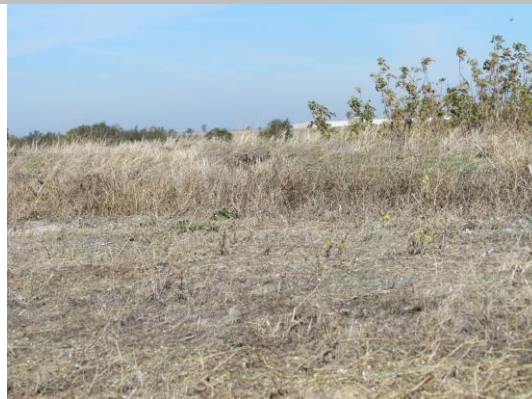
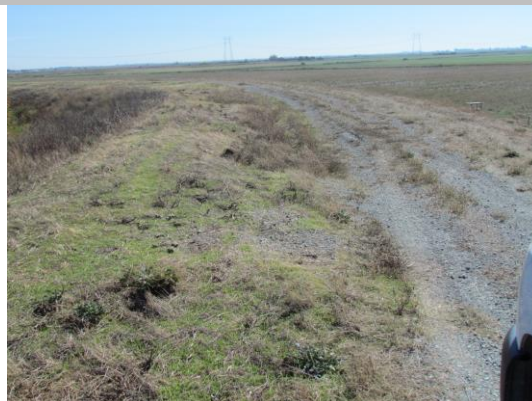
RD 536 Unit 1 looking downstream from 2.69 to levee mile 2.71.

LM Start	2.69	Rating **	U	Issue No.	56 (cont)	
LM End	2.71	Issue Type +	Ma	Location *	CR	
Category	Earthen Levee			GPS Latitude/Longitude		
				Start		End
Item	Crown Surface / Depressions / Rutting			38.255197 °		38.254973 °
				-121.737932 °		-121.737577 °
DWR ID	DWR_RD0536_01_f_2014_56					
Comment Code						
C2 : Repair depressions or ruts in the crown or slope.						
Inspector Comment						
District need to monitor the levee crown roadway at this location. There are some issues here.

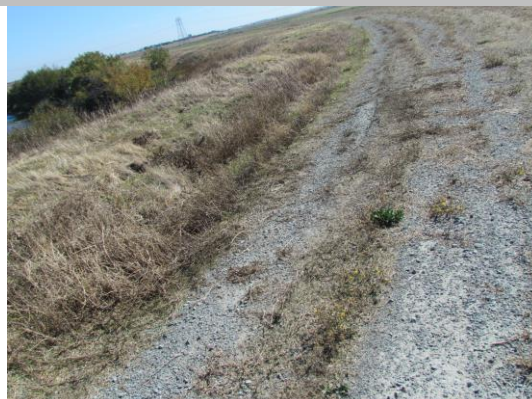
RD 536 Unit 1 levee mile 2.69 another angle of the subsidence.

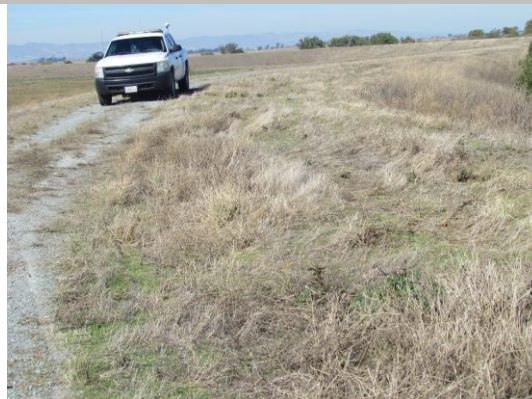
LM Start	2.69	Rating **	U	Issue No.	56 (cont)	
LM End	2.71	Issue Type +	Ma	Location *	CR	
Category	Earthen Levee			GPS Latitude/Longitude		
				Start		End
Item	Crown Surface / Depressions / Rutting			38.255197 °		38.254973 °
				-121.737932 °		-121.737577 °
DWR ID	DWR_RD0536_01_f_2014_56					
Comment Code						
C2 : Repair depressions or ruts in the crown or slope.						
Inspector Comment						
District need to monitor the levee crown roadway at this location. There are some issues here.

Looking upstream at subsidence waterside of levee crown.

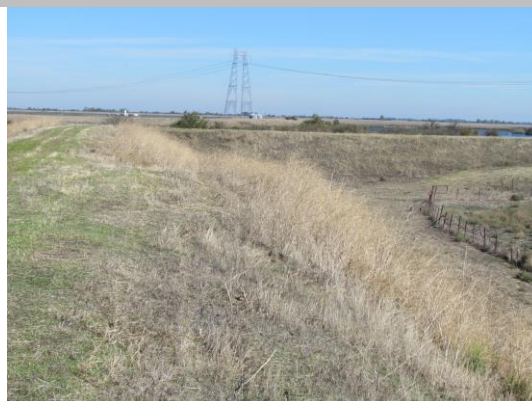
RD 536 LEVEE MILE 2.85 - 3.71.

LM Start	2.85	Rating **	U	Issue No.	2
LM End	3.71	Issue Type +	Ma	Location *	LS
Category	Earthen Levee			GPS Latitude/Longitude	
				Start	End
Item	Vegetation			38.255302 °	38.252008 °
				-121.735210 °	-121.726342 °
DWR ID	DWR_RD0536_01_f_2016_2				
Comment Code					
V1 : Control annual grass and weeds on the levee slopes and easements.					
Inspector Comment					
Remove the tall dead weeds on the landside slope.

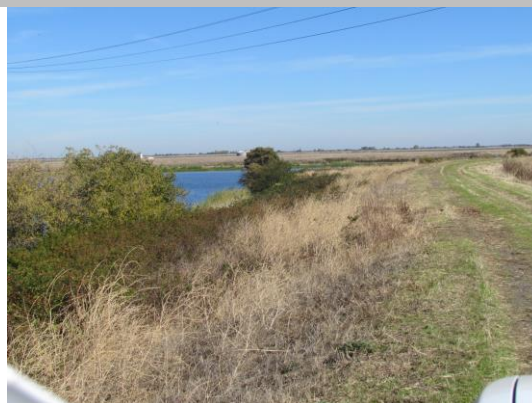
RD 536 Unit 1 levee mile 3.24- 4.04 looking downstream at the waterside levee slope.

LM Start	3.28	Rating **	U	Issue No.	25
LM End	4.04	Issue Type +	Ma	Location *	WS
Category	Earthen Levee			GPS Latitude/Longitude	
				Start	End
Item	Vegetation			38.256530 °	38.250313 °
				-121.728377 °	-121.721228 °
DWR ID	DWR_RD0536_01_f_2016_25				
Comment Code					
V1 : Control annual grass and weeds on the levee slopes and easements.					
Inspector Comment					
Remove the dead tall weeds from the waterside slope and toe.

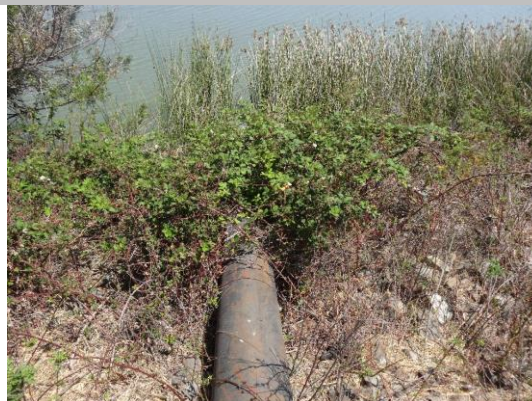
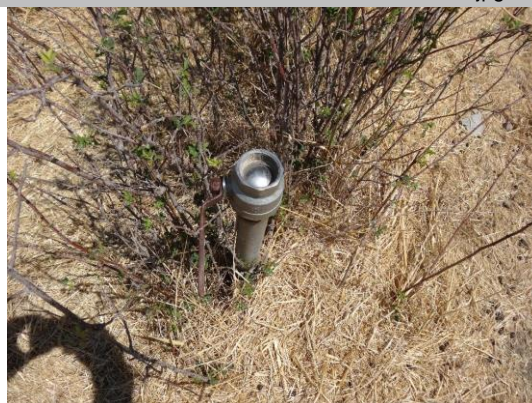
FS_ID:49314
DS_ID:24023
EP_NO: N/A
Repair Type: Non-Urgent
Crossing Status: Found
UCIP Comments: 06/01/2016 Could not see flapgate in water. Pipes still in use. No cover over pressure relief valve on WS slope. 08/13/2013:- Field discovered pipe.- Needs more information from the LMA/ DWR Inspector. - Dense vegetation on WS.- Pump feeds both pipes.
FIELD_STRUCT_DESC: 1 of 2: 18-inch steel drainage pipe through the levee, approximately 4 feet below the crown. Pump (called the "Buddha pump") in pump house on the landside (LS) at the drainage ditch. Pressure breaker on the waterside (WS) slope. Pump and pipes are used by the district (per district president David Hearn) but could not identify permit information. Landowner is Dan Hearn per Solano County Assessor's Office (Parcel No. 0042-180-220).
FS Date: 6/1/2016

WS view: exposed 18" steel pipe on levee slope.

WS view: pressure breaker/valve on levee slope.

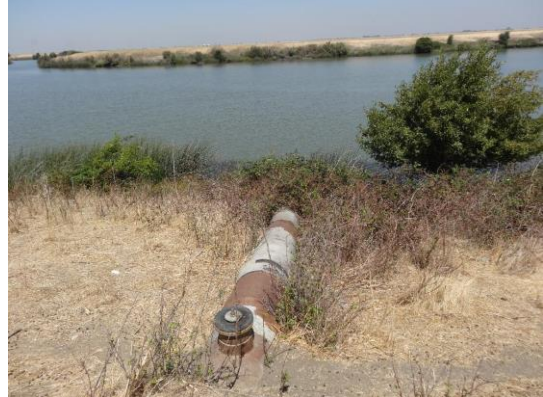
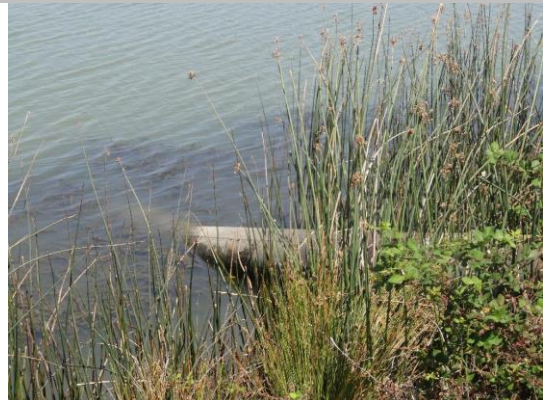
Comment Code					
Inspector Comment					
FS_ID:49317 DS_ID:22719 EP_NO: 2131 Repair Type: Non-Urgent Crossing Status: Found UCIP Comments: 06/01/2016 New pump recently installed. Flapgate not visible though not required under condition of Permit No. 2131. No positive closure device found, which, if missing, is a violation of Condition 8 of Permit No. 2131. Need a name change permit for new owner RD0536. Siphon breaker missing cover.08/13/2013 Pump is missing at the time of inspection. May be taken out for repair.Flap gate on waterward end not found/visible as pipe was submerged into water.Pipe itself is a walkway with steel handrail. FIELD_STRUCT_DESC: 20-inch drainage pipe through the levee, 1.5 feet below the crown. Pump (replaced recently) on steel platform in drain ditch on landside (LS) toe. Siphon breaker on waterside (WS) slope exposed on both slopes (only found on WS in 2016). Walkway over pipe on LS leads to pump platform. Pipe and pump is now used by the district, per district president David Hearn. (Permit No. 2131, 1955 - California Packing Corporation). FS Date: 6/1/2016

WS view: exposed steel pipe with siphon breaker on levee slope.

WS view: steel pipe submerged into water in the stream.

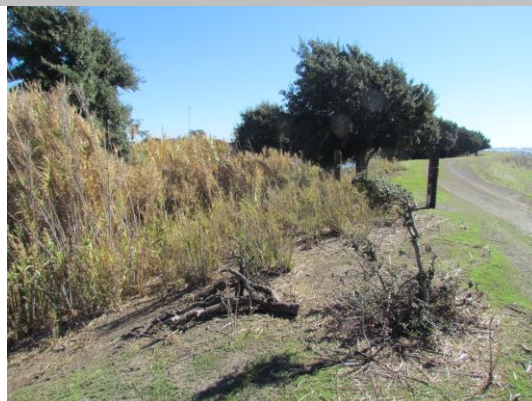
RD 536 Unit 1 levee mile 4.44-4.65 waterside slope and shoulder.

LM Start	4.44	Rating **	U	Issue No.	20
LM End	4.65	Issue Type +	Ma	Location *	WS
Category	Earthen Levee			GPS Latitude/Longitude	
				Start	End
Item	Vegetation			38.248980 °	38.248017 °
				-121.714990 °	-121.711852 °
DWR ID	DWR_RD0536_01_f_2015_20				
Comment Code					
V2 : Remove the wild growth other than native grasses from the levee slopes.					
Inspector Comment					
Unsatisfactory growth of auroondo present on waterside slope need to be removed.

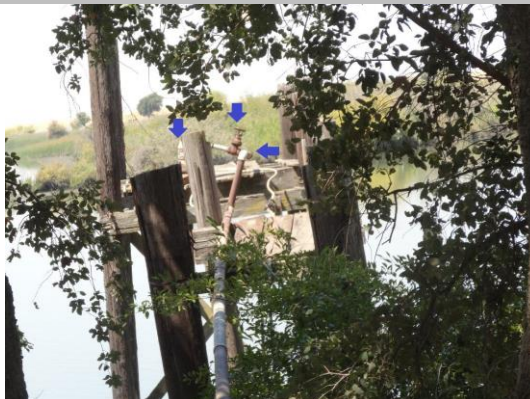
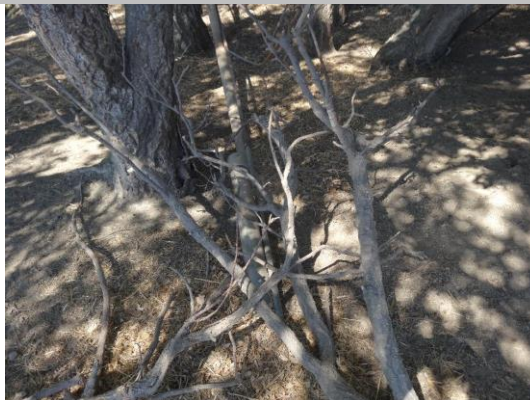
FS_ID:49318
DS_ID:22720
EP_NO: 10116
Repair Type: Non-Urgent
Crossing Status: Found
UCIP Comments: 06/01/2016 Pipe is an abandoned crossing per conversation with district president David Hearn. Pipe seems to be abandoned. Catwalk and pumphouse on riverside not found. It is not clear whether the pipe pass through the levee or not. Needs more info from LMA/DWR Inspector.
FIELD_STRUCT_DESC: 3-inch B.I. galvanized pipe through levee 4.0 feet below crown. Concrete cradle and tank on waterward slope (ABO No.10116, 1975). Catwalk and pumphouse on riverside. Originally included in the 1953 O&M manual, Sac 106, May 1953.
FS Date: 8/13/2013

WS view: pump, pipe, gate valve, and wooden piling structure in the stream.

WS view: exposed pipes on levee shoulder.

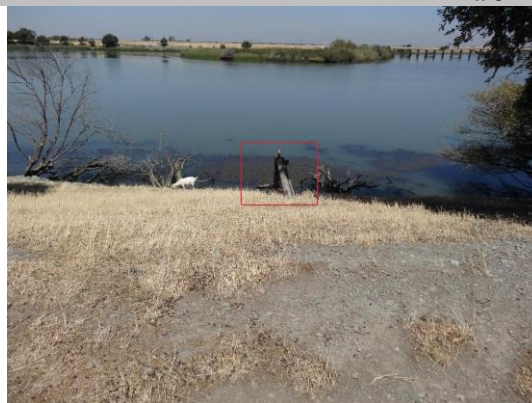
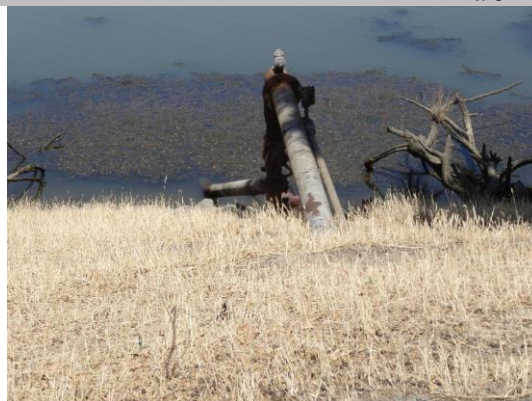
LM Start	5.10	Rating **	M	Issue No.	72
LM End	5.10	Issue Type +	En	Location *	WS
Category	Supplemental			GPS Latitude/Longitude	
				Start	End
Item	DWR UCIP Field Study			38.245783 °	38.245783 °
				-121.705999 °	-121.705999 °
DWR ID					
Comment Code					
Inspector Comment					
FS_ID:49319 DS_ID:24664 EP_NO: N/A Repair Type: Non-Urgent Crossing Status: Found UCIP Comments: 06/01/2016 According to district president David Hearn, landowner is Silva and crossing is abandoned.08/13/2013:Field discovered pipe crossing.Needs more information from LMA/DWR Inspector. Also needs more detailed inspection. FIELD_STRUCT_DESC: Approximately 6-inch steel pipe and an electric conduit through levee. A slant pump in steel support on channel bank. Gate valve on the pipe. No pipes and appurtenances on landside. Field discovered pipe crossing. FS Date: 8/13/2013

WS view: pipe and pump on channel bank.

WS view: closer view of pipe and pump on channel bank.

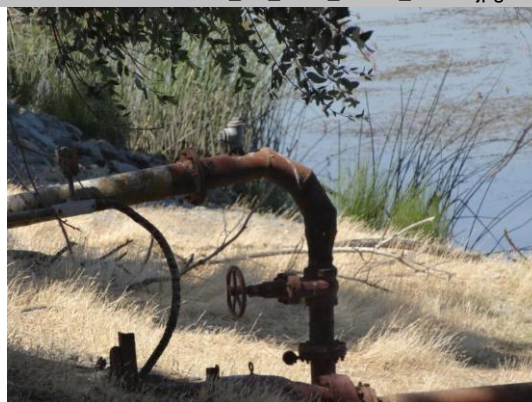
LM Start	5.10	Rating **	M	Issue No.	66
LM End	5.10	Issue Type +	En	Location *	WS
Category	Supplemental			GPS Latitude/Longitude	
				Start	End
Item	DWR UCIP Field Study			38.245783 °	38.245783 °
				-121.705999 °	-121.705999 °
DWR ID					
Comment Code					
Inspector Comment					
FS_ID:20543 DS_ID:22721 EP_NO: 3873 Repair Type: Non-Urgent Crossing Status: Found UCIP Comments: Pipe seems to be abandoned.Needs proper abandonment. FIELD_STRUCT_DESC: 6-inch pipe through levee 2. 0 feet below crown. Pump on concrete base on waterward slope. Gate valve on waterward slope. (Permit No.3873, 1962). FS Date: 8/13/2013

WS view: abandoned pipe, pump, conduit, and gate valve on levee slope.

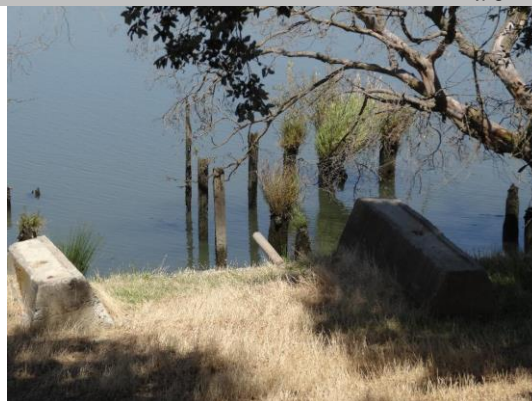
LM Start	5.12	Rating **	M	Issue No.	67 (cont)
LM End	5.12	Issue Type +	En	Location *	WS
Category	Supplemental			GPS Latitude/Longitude	
				Start	End
Item	DWR UCIP Field Study			38.245588 °	38.245588 °
				-121.705723 °	-121.705723 °
DWR ID					
Comment Code					
Inspector Comment					
FS_ID:20544					
DS_ID:24024					
EP_NO: N/A					
Repair Type: Non-Urgent					
Crossing Status: Found					
UCIP Comments: - field discovered pipe.- seems abandoned pipe.					
Needs proper abandonment.					
FIELD_STRUCT_DESC: *ABANDONED* 6-inch galvanized iron pipe on					
top of concrete pad and through levee. Details not available.					
FS Date: 8/13/2013

WS view: abandoned steel pipe on concrete pad.

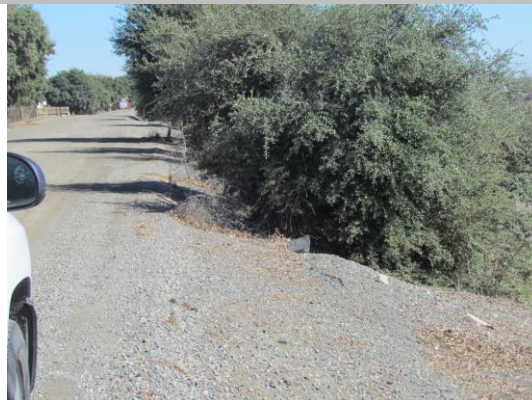
RD 536 Unit 1 levee miles 5.17-5.39 landside.

LM Start	5.17	Rating **	U	Issue No.	65
LM End	5.39	Issue Type +	Ma	Location *	LS
Category	Earthen Levee			GPS Latitude/Longitude	
				Start	End
Item	Vegetation			38.245300 °	38.245742 °
				-121.704909 °	-121.700893 °
DWR ID	DWR_RD0536_01_s_2014_65				
Comment Code					
V7 : Trees / Woody Vegetation					
Inspector Comment					
These young oak trees need to be removed from the landward slope and shoulder before they get any larger.

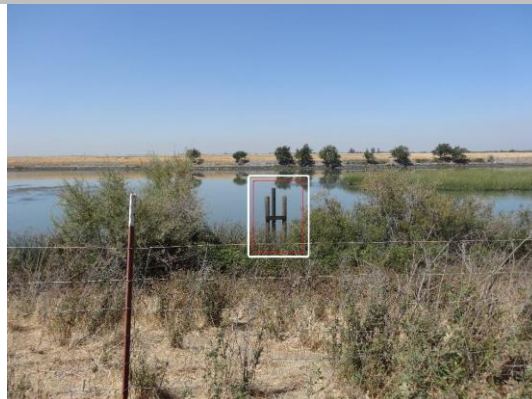
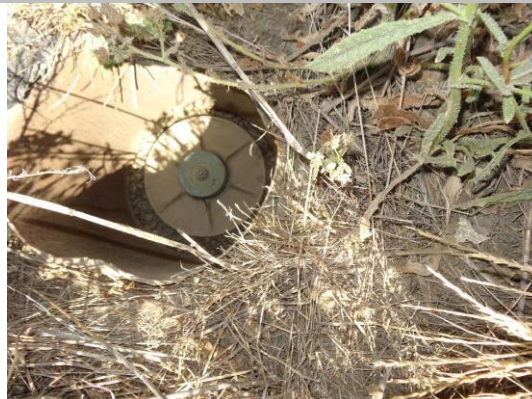
FS_ID:20563
DS_ID:22722
EP_NO: 7208
Repair Type: Non-Urgent
Crossing Status: Found
UCIP Comments: - siphon breaker needs cover/protection.- service pole on landside of the levee.
FIELD_STRUCT_DESC: 30-inch steel drain pipe through levee 5.7 feet below crown. Pump in piling structure in drain ditch on landward side. Siphon breaker on waterward shoulder. (Permit No. 7208, 1971)
FS Date: 8/13/2013

WS view: wooden & steel piles on the slough. Probably the supports are for pipe and flap gate. Not accessible due to fence.

WS view: uncovered siphon breaker on levee shoulder. It needs protection.

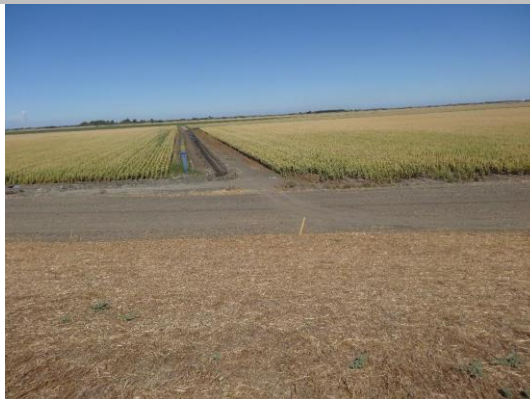
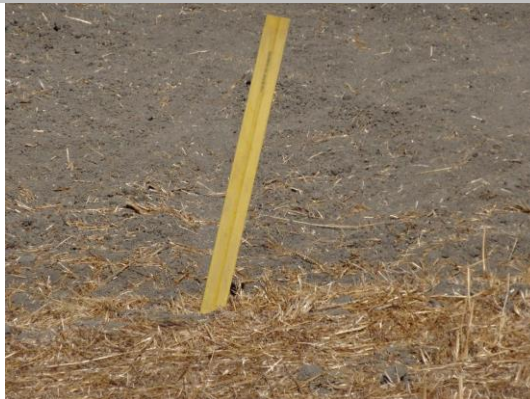
FS_ID:20664
DS_ID:22732
EP_NO: 17829
Repair Type: Non-Urgent
Crossing Status: Indicator Found
UCIP Comments: Indicator is found only on WS. The indicator is different than standard indicator. Needs more info from LMA/DWR Inspector.
FIELD_STRUCT_DESC: 3.5-inch welded steel natural gas pipe through levee 44.0 feet below crown (Permit No. 17829, 2004).
FS Date: 8/13/2013

WS view: overview of levee slope and gasline indicator. The indicator is different than standard indicators.

WS view: closer look at gasline indicator. The indicator is different than standard indicators.

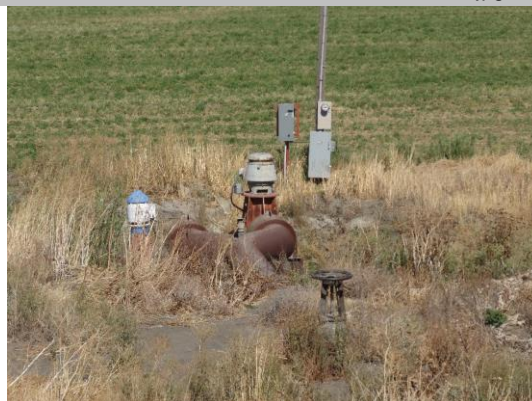
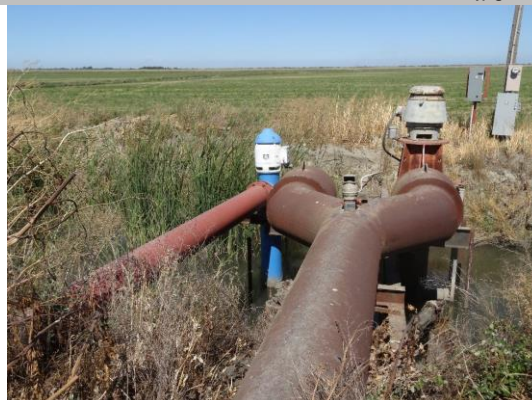
LM Start	2.50	Rating **	M	Issue No.	25
LM End	2.50	Issue Type +	En	Location *	WS
Category	Supplemental			GPS Latitude/Longitude	
				Start	End
Item	DWR UCIP Field Study			38.210063 °	38.210063 °
				-121.691768 °	-121.691768 °
DWR ID					
Comment Code					
Inspector Comment					
FS_ID:20647 DS_ID:24025 EP_NO: N/A Repair Type: Non-Urgent Crossing Status: Found UCIP Comments: Needs more info from LMA/DWR Inspector. Pump and pipe looks new. FIELD_STRUCT_DESC: A 12-inch steel pipe with vertical pump on drainage ditch. No other details available. FS Date: 8/13/2013

WS view: overview of pipe and pump (left). Big pump and appurtenances (right) for 24" steel pipe.

WS view: closer view of pipe and pump (left). Big pump and appurtenances (right) for 24" steel pipe.

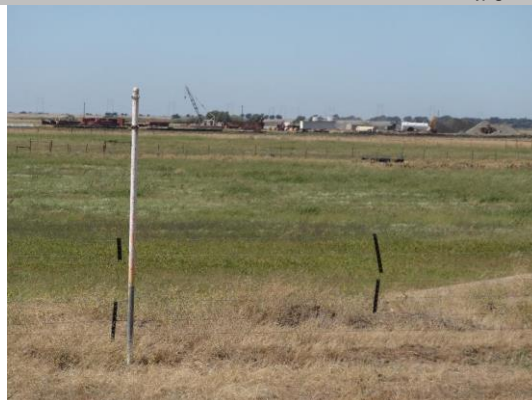
LM Start	4.14	Rating **	M	Issue No.	27
LM End	4.14	Issue Type +	En	Location *	WS
Category	Supplemental			GPS Latitude/Longitude	
				Start	End
Item	DWR UCIP Field Study			38.195875 °	38.195875 °
				-121.695177 °	-121.695177 °
DWR ID					
Comment Code					
Inspector Comment					
FS_ID:41845 DS_ID:22731 EP_NO: 1217 Repair Type: Non-Urgent Crossing Status: Indicator Found UCIP Comments: Gasline needs markers on both slopes. Existing markers in disrepair. FIELD_STRUCT_DESC: 8.625-inch gas line through levee at unknown elevation (Permit No. 1217, 1947). FS Date: 8/13/2013

WS view: gasline indicator across the channel.

LS view: gasline indicator on levee toe.

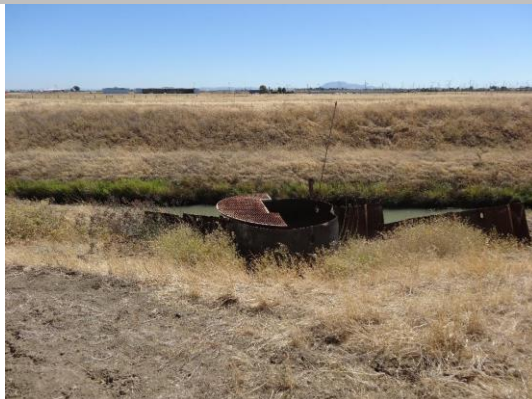
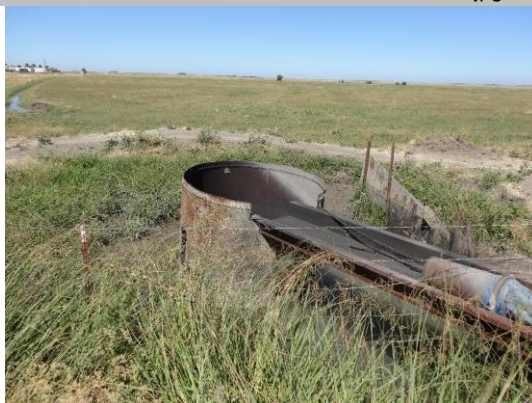
LM Start	4.36	Rating **	M	Issue No.	28
LM End	4.36	Issue Type +	En	Location *	WS
Category	Supplemental			GPS Latitude/Longitude	
				Start	End
Item	DWR UCIP Field Study			38.196429 °	38.196429 °
				-121.698962 °	-121.698962 °
DWR ID					
Comment Code					
Inspector Comment					
FS_ID:46813					
DS_ID:22735					
EP_NO: N/A					
Repair Type: Non-Urgent					
Crossing Status: Found					
UCIP Comments: Recommend owner contact CVFPB to provide updated owner info and obtain necessary permit for this crossing.					
FIELD_STRUCT_DESC: 18-inch steel pipe on WS. Steel standpipe on both sides of the levee. Temporary canvas about 2" below crown. Per 2015 Inspection Report provided by Herman Phillips, diesel motor found on WS and owner is Mr. Page Baldwin.					
FS Date: 8/13/2013

WS view: steel standpipe on levee slope.

LS view: steel standpipe on levee slope.
